Evaluation of Corrosion Attack at homogeneous weld joint of austenitic pipe and flange

Dana TONAROVA¹, Petr BRABEC¹

¹UJV Rez, a. s., Husinec-Rez, Czech Republic

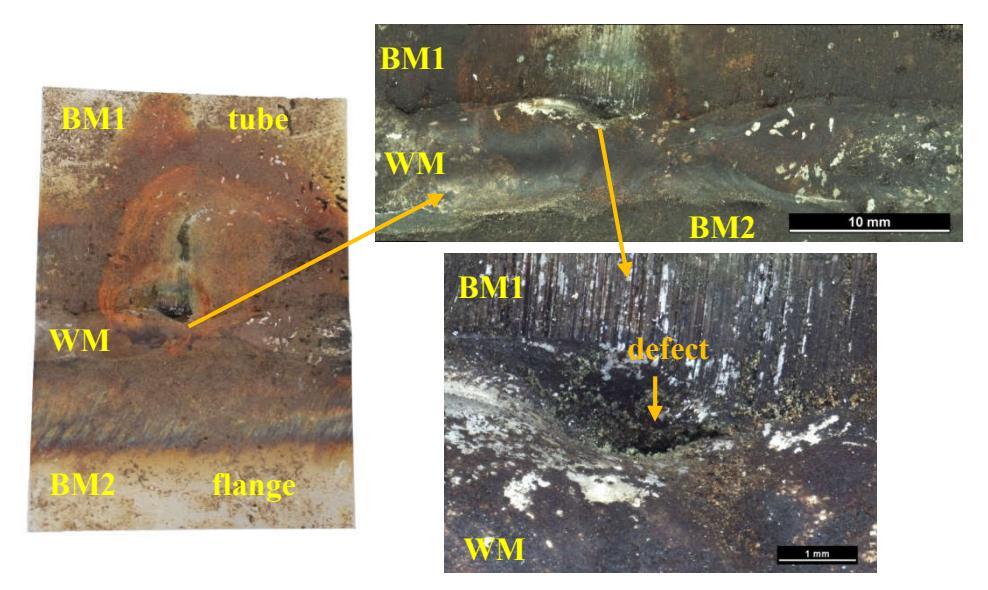
Near the NDT detected defect (Fig. 1), there was a visible orange coloured corrosion layer on the inner surface and green coloured corrosion layer at the defect mouth. According to semiquantitative analysis, the green corrosion layer contained increased amount of Cl and S (0.3 wt. % Cl and 0.6 wt. % S).

Fig. 1: Internal surface of weld joint at location of the defect; detail of the defect.

To eliminate the pitting corrosion, it is recommended to replace the austenitic material with another material (e.g. carbon steel for which corrosion attack is predictable).

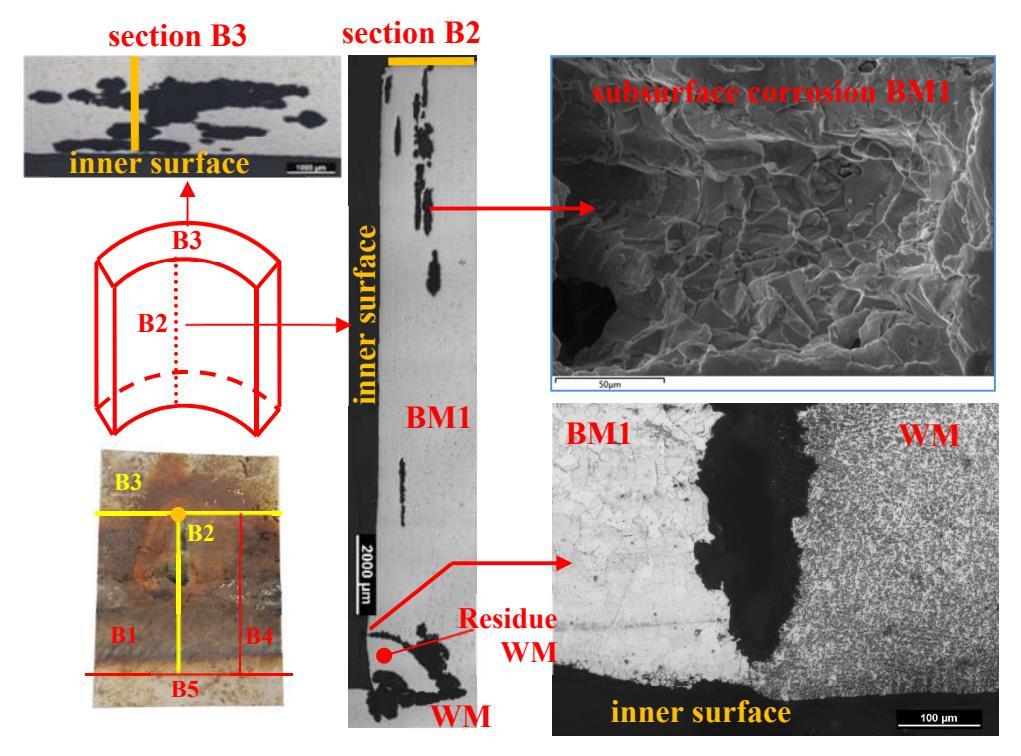
The evaluated defect in cross section (section B2, Fig. 2) probably initiated on the inner surface in the shrinkage groove of the weld root and passed through WM to the BM1-WM interface (depth 2.5 mm). The corrosion attack did not continue along the boundary towards the weld face but was evident at the interface of BM1 and the WM residue. No corrosion attack was associated with the inner surface of the BM1-WM interface in any evaluated cross sections.

Furthermore, the subsurface corrosion was observed in BM1. This corrosion (depth up to 1.7 mm) was not associated with the inner surface of the evaluated cross sections. Etching revealed, that the corrosion attack did not occur at the grain boundaries but attacked whole grains. Selective dissolution of the matrix was evident on the cavity surface according to SEM documentation. Corrosion cavities were still active with no corrosion layer on their surface.

The subsurface corrosion of BM1 continued at the perimeter cut approximately 15 mm from the WM (section B3, Fig. 2). The attack nature was similar as in the cross section B2, the length of the subsurface corrosion is approximately 6 mm.

Fig. 2: Documentation of materials corrosion attack at cross section B2 a B3.

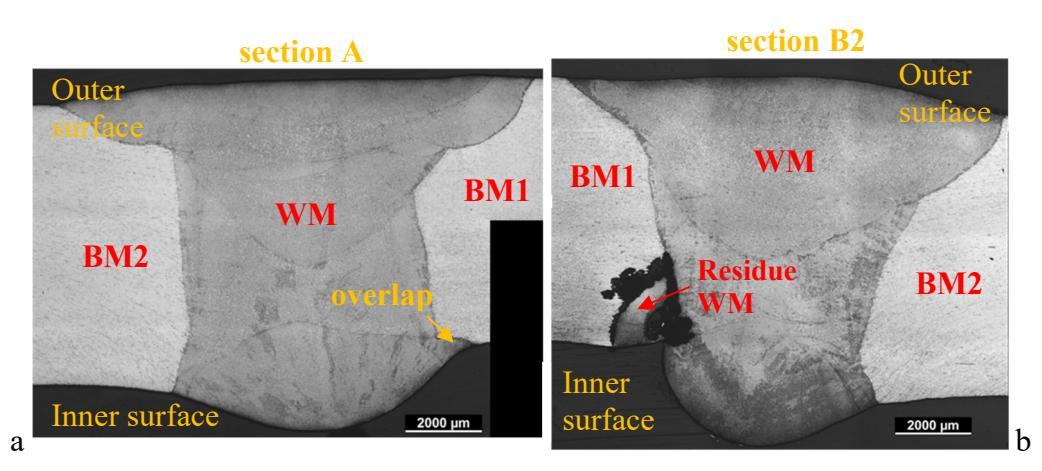
The evaluation was carried out on two cross sections of weld joint to compare the microstructure and microhardness at the defect-free position (section A) and at the defect position (section B2); see Fig. 3. The cross-sections of weld joint correspond to the longitudinal direction to the forming axis of tube.

Fig. 3: Macrostructure of materials in defect-free place (a) and in place with defect (b).

There was no difference in microstructure and microhardness between cross section A (defect-free) and B2 (defect position) observed.
