# Corrosion Effects on High Strength Duplex Stainless Steel Nets for Offshore Fish Farming

**Matthias SORG<sup>1</sup>, Arnulf HÖRTNAGL<sup>2</sup>, Paul GÜMPEL<sup>3</sup>, Urs DORNBIERER<sup>4</sup>**

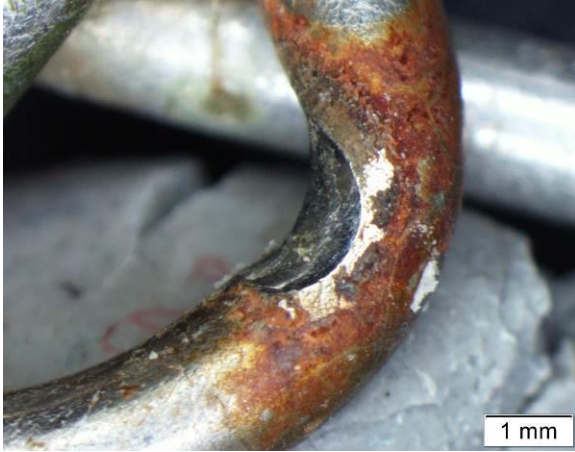
*Figure 2 : erosion in contact point*

The test cages for real condition tests are installed in Chile. Here, the stainless steel nets are used for predator protection of fish farms. The used net system is schematically shown in Figure 1. After one year testing under real conditions, the contact points show mostly more or less erosion without a corrosion attack, see Figure 2 & Figure 3. The corrosion products around the contact points come from the abrasion. At some contact points corrosion occurs additionally to erosion. Figure 4 & Figure 5 show corrosion on a 1.4362 sample. The corrosion attack is deep and reduces the wire diameter clearly. A corrosion attack in contact points of 1.4462 samples is very rare and when it appears, the attack is circular, see Figure 6 & Figure 7.

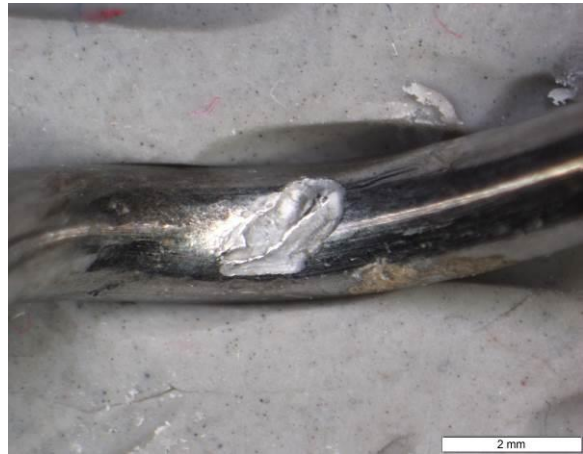
*Figure 5 : erosion and corrosion in contact point, 1.4362*

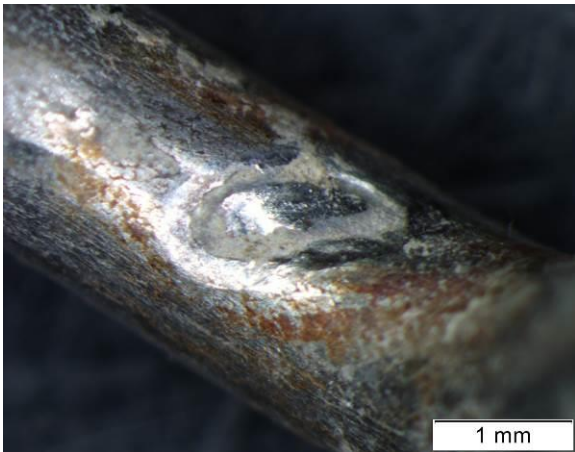
*Figure 6 : erosion and corrosion in contact point, 1.4462*
