# Crevice Corrosion Characteristics of Alloy 690 in High-Temperature Oxygenated Pure Water

Xinqiang WU<sup>1</sup>, Fangqiang NING<sup>1</sup>, En-Hou HAN<sup>1</sup>, Wei KE<sup>1</sup>

<sup>1</sup> CAS Key Laboratory of Nuclear Materials and Safety Assessment, Liaoning Key Laboratory for Safety and Assessment Technique of Nuclear Materials, Institute of Metal Research, Chinese Academy of Sciences, 62 Wencui Road, Shenyang 110016, P.R. China, E-mail: xqwu@imr.ac.cn

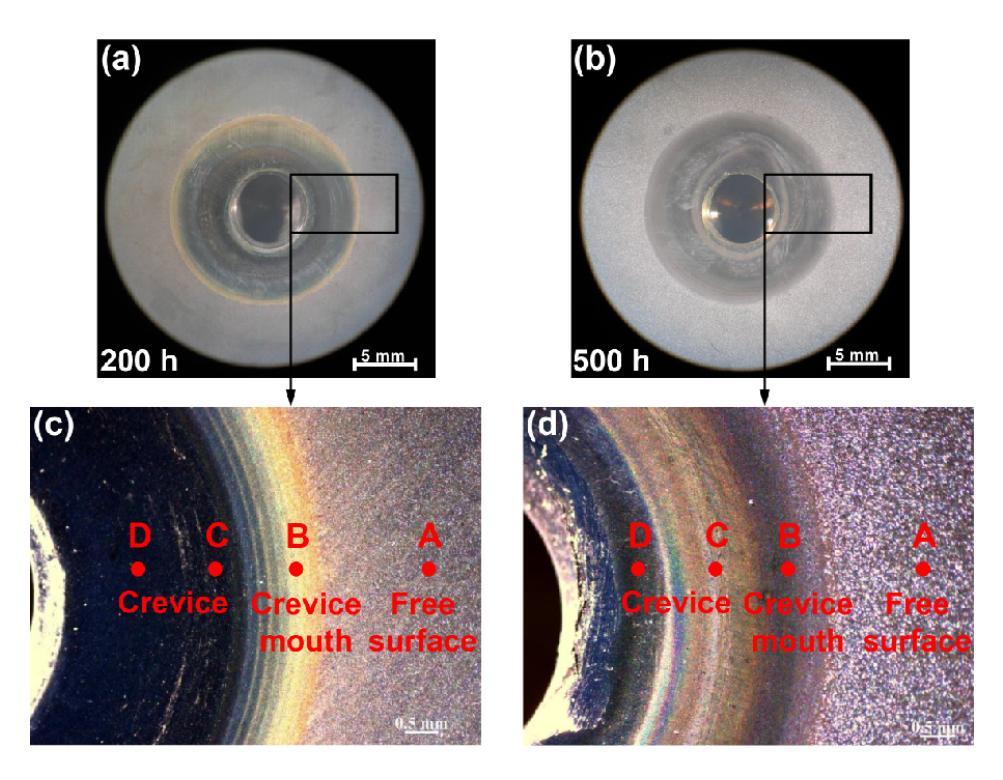
Fig. 1 Surface macro-morphologies of Alloy 690 crevice corrosion specimens after 200 h and 500 h exposure tests in 290°C water containing 3 ppm DO.

Fig. 1 shows the surface macro-morphologies of Alloy 690 crevice corrosion specimens after 200 h and 500 h exposure tests in 290°C water containing 3 ppm DO. Different colors and corrosion morphologies were observed on the free and crevice surfaces, suggesting that crevice corrosion surely took place during the exposure tests in oxygenated high-temperature water and the oxide films were different at different sites along the crevice. The surface of specimens can be divided into four regions, namely, free surface (region A), crevice mouth (region B), within the crevice (region C) and deeper site within the crevice (region D) (Fig. 2c and 2d). The width of region B for the 500 h exposed specimen was much wider than that for the 200 h exposed one, indicating that the crevice corrosion became serious with increasing the exposure time.

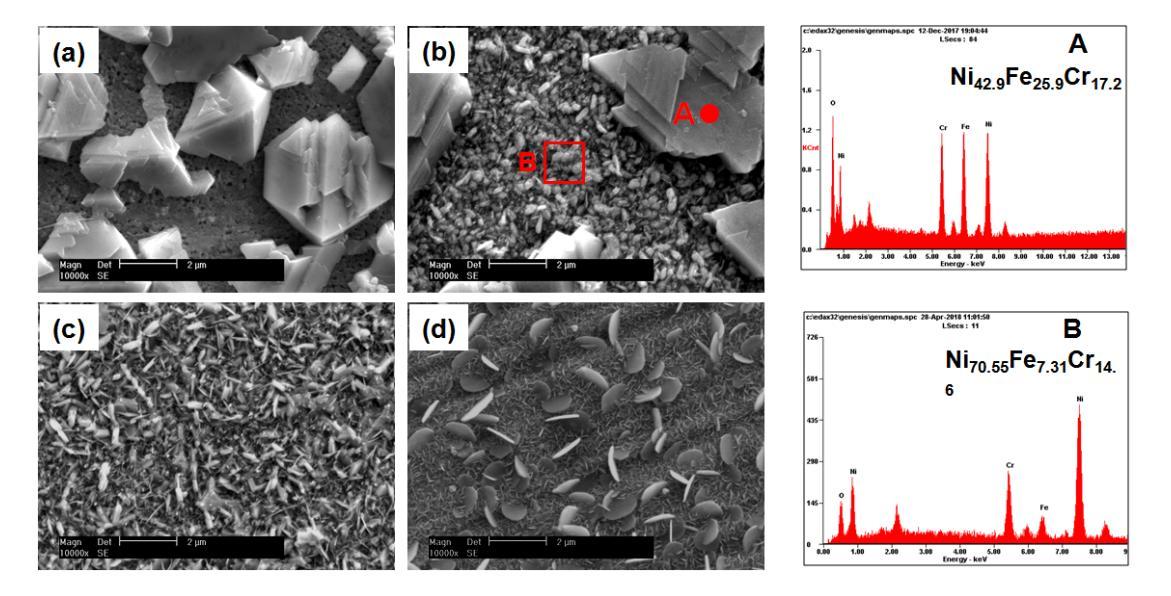
Fig. 2 SEM morphologies and EDS results of oxide films on the free and crevice surfaces of Alloy 690 crevice corrosion specimens after 500 h exposure tests. (a) region A (b) region B (c) region C (d) region D.

Fig. 2 show the SEM morphologies and EDS results of oxide films on the free and crevice surfaces of Alloy 690 crevice corrosion specimens after 500 h exposure tests in 290°C water containing 3 ppm DO. A kind of sparse oxide clusters with some straight sidesteps were observed in the region A. The inner layer of oxide films appeared porous (Fig. 2a). The previous work has proven that the oxide clusters were spinel oxides and the porous inner oxides were NiO [9, 10]. A few oxide clusters, numerous small oxide particles and minor plate-like oxides were observed in the region B (Fig. 2b). EDS results indicated that the Fe

and Ni contents in the oxide clusters and small oxide particles in the region B were different. Some spinel oxides, needle-like oxides and lamellar oxides were observed in the region C (Fig. 2c). Some large lamellar oxides were observed in the outer layer and small oxides were found in the inner layer (Fig. 2d).

structure as the general corrosion. The outer layer of oxide film was mainly Ni-Fe spinels and the inner layer was porous NiO (Fig. 2a). However, the hydrochemistry conditions (including metallic ions, DO and pH) within the crevice change with increasing the exposure time, resulting in that different types of oxides forms in different regions. The presence of the crevice geometry significantly affects the mass transport between the bulk and crevice solutions, resulting in ionic concentration gradients and depleted of oxygen within the crevice [5, 16]. Since the consumption rate of DO within the crevice is faster than the diffusion rate of DO from the bulk solution into crevice solution, the DO plays a key role in the oxidation process of crevice corrosion. The crevcie depth in the present work was 4 mm, which can lead to a rapid decrease of DO concentration within the crevice. Decreasing DO concentration could result in a lower electrochemical corrosion potential (ECP) of the metal [17]. Therefore, the presence of DO concentration gradient from the crevice mouth to the deeper site within the crevice can result in an obvious potential drop within the crevice. In addition, the metallic ions produced by dissolution within the crevice are enriched due to the restricted geometry. The hydrolysis of these metallic ions can result in a decrease of pH value in the solution within the crevice. As a result, the growth mechanism of oxides within the crevice is different from that on the free surface.

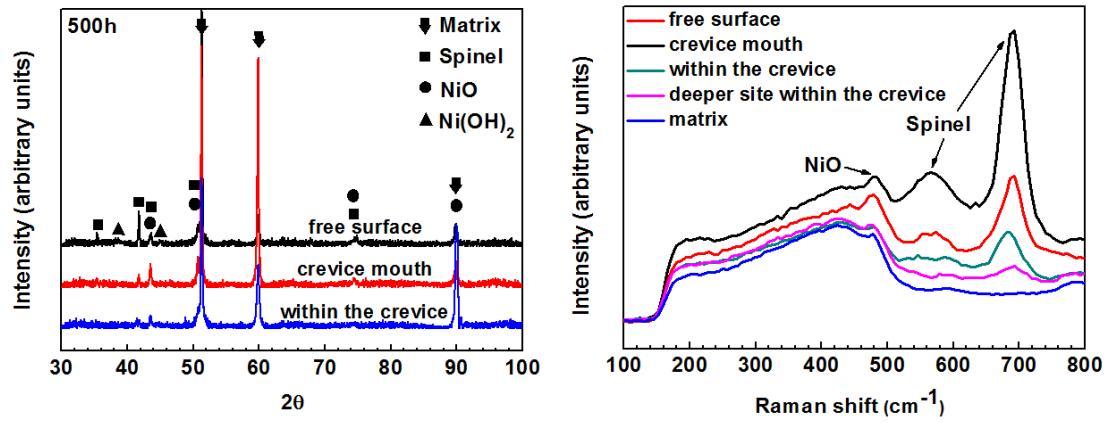
Fig. 3 XRD patterns (left) and Raman spectroscopies (right) of the oxide films on the free and crevice surfaces of Alloy 690 after 500 h exposure test.

Fig. 3 shows the XRD patterns (left) and Raman spectroscopies (right) of the oxide films on the free and crevice surfaces of Alloy 690 after 500 h exposure test in 290°C water containing

3 ppm DO. The characteristic peaks of spinel oxides and NiO were detected in the regions A, B and C. The weak characteristic peak of  $Ni(OH)_2$  was found only on the free surface. The peak intensity of spinel oxides on the free surface was stronger than that on the crevice surface. The Raman characteristic peaks (560 cm<sup>-1</sup> and 693 cm<sup>-1</sup>) of spinel oxides [11-14] were detected in all regions. The Raman characteristic peaks (480 cm<sup>-1</sup>) of NiO [12, 13, 15] were detected in the regions A and B. It was found that the spinel oxides at the outermost surface in the region B were more than those in the other regions, and the region D had least spinel oxides.

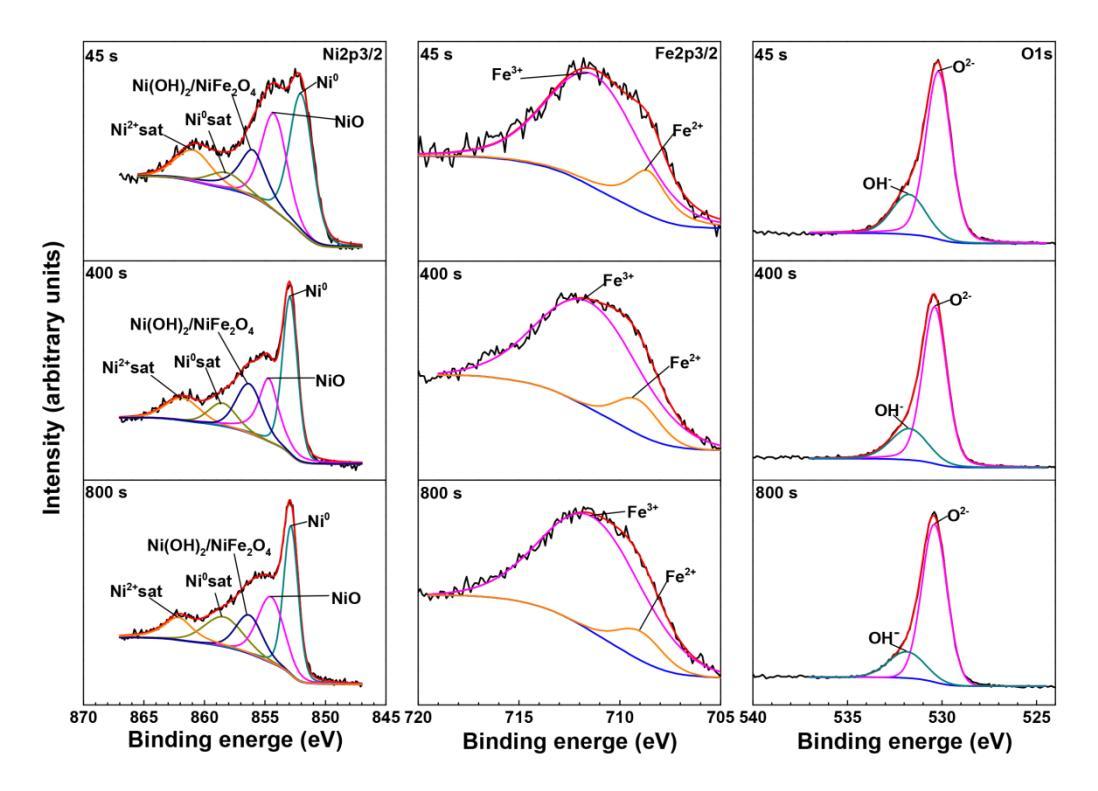
Fig. 4 Detailed XPS spectra of Cr 2p3/2, Ni 2p3/2, O1s in the oxide film formed at the crevice mouth of Alloy 690 after 500 h exposure tests in 290 °C water containing 3 ppm DO.

Detailed XPS spectra of Cr 2p3/2, Fe 2p3/2, Ni 2p3/2, O1s in the oxide films from the free surface to the deeper site within the crevice of Alloy 690 after 500 h exposure test were analyzed carefully. At the free surface (region A), the Ni 2p3/2 spectrum consisted of NiO, NiFe<sub>2</sub>O<sub>4</sub>, NiO and Ni(OH)<sub>2</sub> (Fig. 4). The Fe 2p3/2 spectrum consisted of Fe<sup>3+</sup> and a small amount of  $Fe^{2+}$ . The O 1s spectrum shows that the hydroxides content was higher than oxides. It is concluded that the oxide films mainly consisted of NiO, (Ni, Fe)Fe<sub>2</sub>O<sub>4</sub> and a small amount of Ni(OH)<sub>2</sub> by combining the XPS results with SEM, XRD and Raman results, which is consistent with the work of Kuang [9, 10]. At the crevice mouth (region B), the Ni 2p3/2 spectrum consisted of NiO, NiFe<sub>2</sub>O<sub>4</sub>, Ni<sup>0</sup> and a small amount of Ni(OH)<sub>2</sub> after 45 s sputtering. According to the SEM-EDS results, the presence of NiFe<sub>2</sub>O<sub>4</sub> and NiO in oxides was confirmed. The OH peak was detected in the oxides, and the very low Fe and Cr contents in the oxides proved that the Ni(OH)<sub>2</sub> was present. It was reported that the plate-like oxide formed on Ni-based alloy was Ni(OH)<sub>2</sub> (Fig. 2b) [9]. Within the crevice (region C), the Cr 2p3/2 spectrum exhibited only  $Cr^{3+}$  peak and its satellite peak (Fig. 5). The Ni 2p3/2 spectrum consisted of NiO, NiCr<sub>2</sub>O<sub>4</sub>, Ni<sup>0</sup> and Ni(OH)<sub>2</sub>, and the change of intensity of Ni<sup>0</sup> peak was consistent with that at the crevice mouth. The XRD and Raman results indicated that there were spinel oxides in the oxide films. It is believed that the spinel oxide corresponded to NiCr<sub>2</sub>O<sub>4</sub>. The presences of Cr(OH)<sub>3</sub> and Cr<sub>2</sub>O<sub>3</sub> could be verified by combining the Cr 2p3/2, Ni 2p3/2 and the O 1s spectrums. The XPS and Raman results indicated that the oxide film in the region D mainly contained a large amount of Cr(OH)<sub>3</sub>, Cr<sub>2</sub>O<sub>3</sub> and a small amount of FeCr<sub>2</sub>O<sub>4</sub>. From the outer to inner layer of oxide film, the  $Cr(OH)_3$  content in the oxide film gradually decreased, while the Cr<sub>2</sub>O<sub>3</sub> content increased.

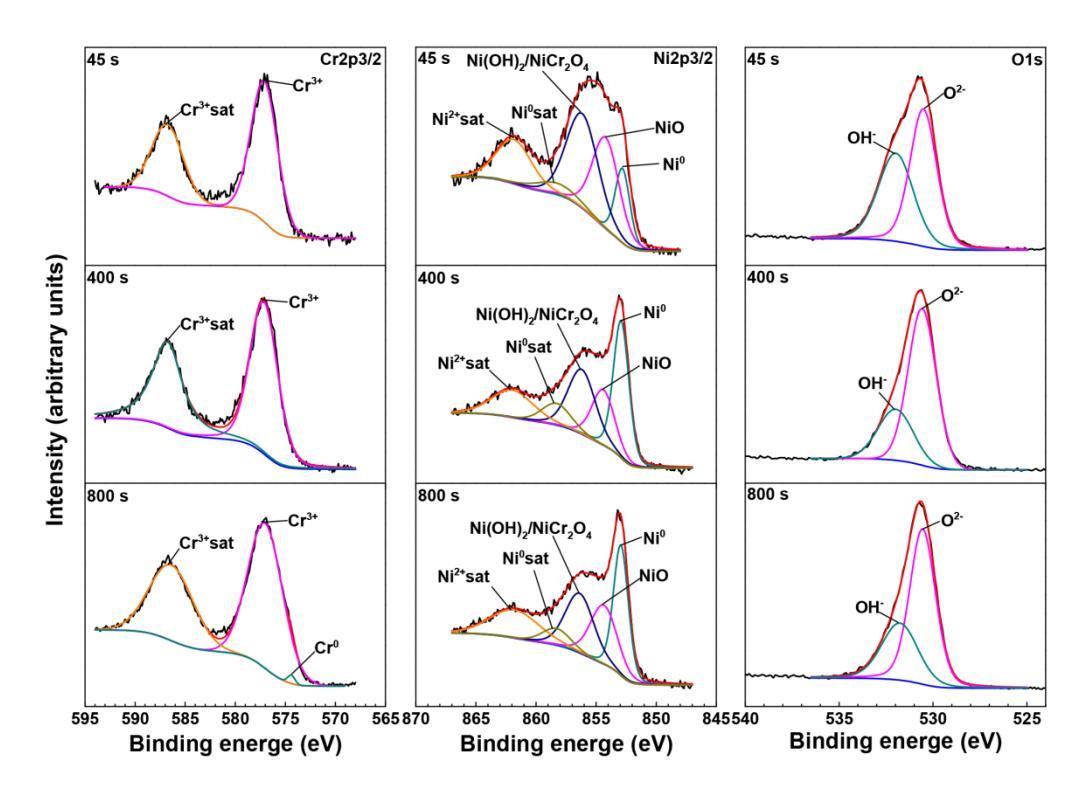
Fig. 5 Detailed XPS spectra of Cr 2p3/2, Ni 2p3/2, O1s in the oxide film formed within the crevice of Alloy 690 after 500 h exposure tests in 290 °C water containing 3 ppm DO.

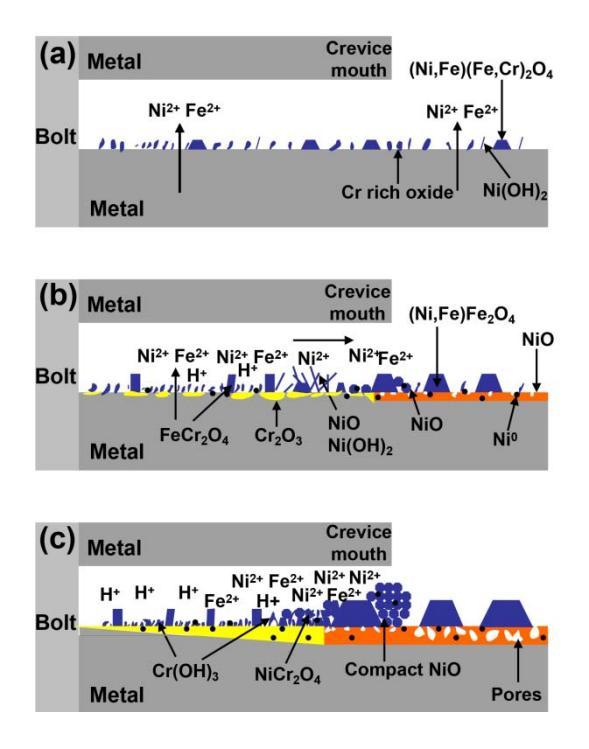
Fig. 6 Schematic of crevice corrosion process of Alloy 690 in 290°C oxygenated pure water.

Fig. 6 shows the schematic of crevice corrosion process of Alloy 690 in 290°C oxygenated pure water. At the early stage, Fe and Ni selectively dissolve from the matrix into hightemperature water and the residual metallic elements are oxidized to Cr-rich oxides (Fig. 6a). With increasing exposure time, large (Ni, Fe)Fe<sub>2</sub>O<sub>4</sub> oxide particles in the outer layer and porous NiO in the inner layer form on the free surface due to the release of Cr into the solution as HCrO<sub>4</sub><sup>-</sup> under high-DO condition. The DO concentration in the crevice solution gradually reduces and the Fe<sup>2+</sup> and Ni<sup>2+</sup> are enriched at the crevice mouth. The DO concentration at the crevice mouth is much higher than that at the deeper site within the crevice. The NiFe<sub>2</sub>O<sub>4</sub> spinels gradually develop at the crevice mouth through the precipitation of the Fe<sup>2+</sup> and Ni<sup>2+</sup>, and the additional Ni<sup>2+</sup> ions react with DO to form NiO particles. Within the crevice, the hydrolysis of Cr<sup>3+</sup> produce large amount of Cr(OH)<sub>3</sub> and result in a decrease of pH value. The NiO and Ni(OH)<sub>2</sub> form due to large amount of Ni<sup>2+</sup> (Fig. 6b). With the development of crevice corrosion, more and more NiFe<sub>2</sub>O<sub>4</sub> and NiO form at the crevice mouth. These oxides enhance the occluded effect and lead to a more serious potential drop within the crevice. The pH value of crevice solution continually decrease and produce more  $Cr(OH)_3$  within the crevice. The low potential and the massive Ni<sup>2+</sup> lead to the formation of NiCr<sub>2</sub>O<sub>4</sub> within the crevice near the crevice mouth. At the deeper sites within the crevice, both the pH value and DO concentration are very low, resulting in formation of FeCr<sub>2</sub>O<sub>4</sub> spinel. At the same time, more and more Cr<sub>2</sub>O<sub>3</sub> form in the inner layer of oxide film. As a result, Cr(OH)<sub>3</sub>, Cr<sub>2</sub>O<sub>3</sub> and FeCr<sub>2</sub>O<sub>4</sub> spinels form at the deeper site within the crevice (Fig. 6c).
